# Home Inspection Report

**123 River Oak Drive Anywhere, VA 00000**

**Inspection Date:**

Thursday, April 10, 2014

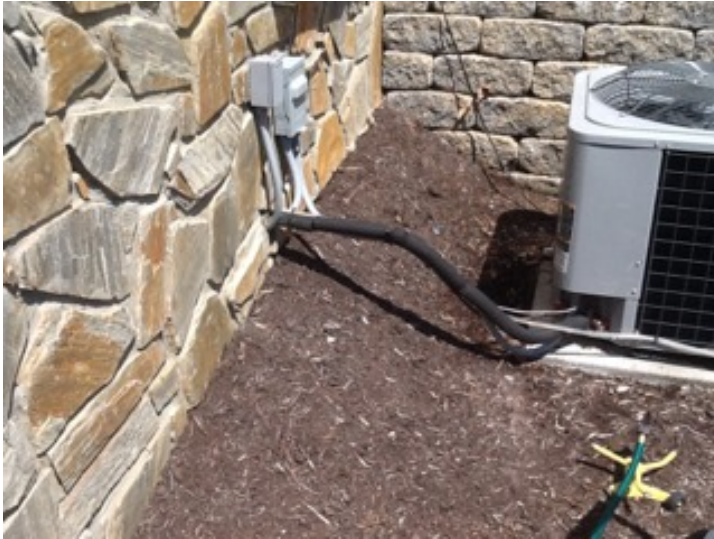
Mulch is piled up on side of basement wall. Water is getting in basement in this areas. Recommend mulch landscaped in this area.
